# FRESHWATER

## FINAL REPORT

### Hennepin County Bedrock Collapse Project

G. Brick, B.J. Bonin, and C.E. Jennings

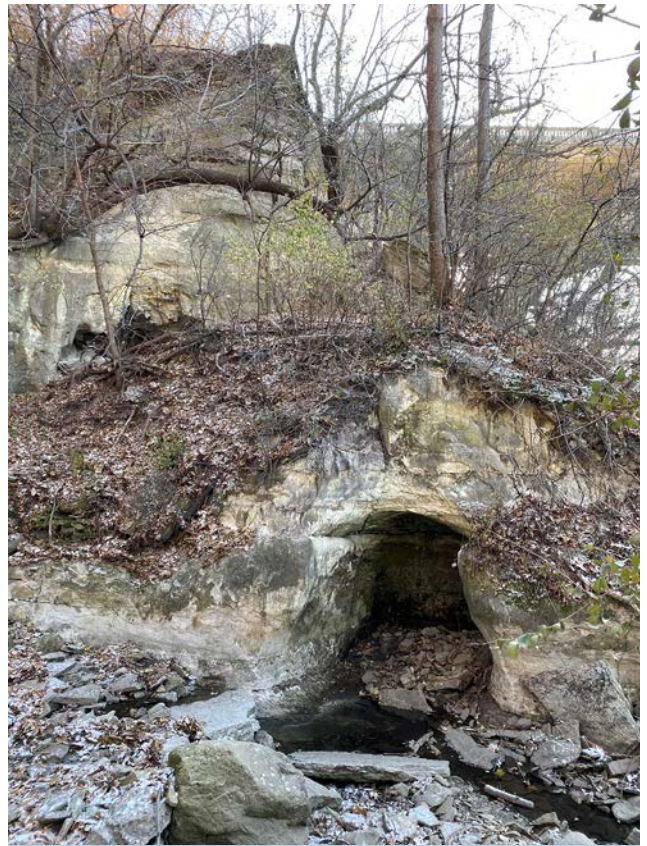
**Cave unit in the St. Peter Sandstone**

As early as Frizell (1883) it was noted, in the wake of the catastrophic Eastman Tunnel debacle, that "The softest stratum at the [St. Anthony] falls is 16 to 22 feet below the bottom of the [Platteville] limestone. The attempt to excavate in this stratum and to keep excavations clear by pumping, has resulted in extensive and dangerous cavities." This was formalized more than a century later by Mazzullo and Ehrlich (1987) as the "Cave Unit." We investigated and extended the model of Mazzullo and Ehrlich (1987) from Ramsey to Hennepin County (Bonin

et al., 2020) which correlates the formation of voids in the St. Peter Sandstone bedrock underlying Minneapolis with tunnel driving in the so-called “Cave Unit” in the middle of the sandstone. This actually suggests a predictive model for bedrock collapse (e.g., Galve et al., 2009; Khomenko, 2008). Our investigation identified that cross-bedded layers of St. Peter Sandstone displayed more erosion features and excavations, whether by human activity or by other wildlife such as birds, than the massive sections of sandstone outcrop. Further, we observed that seepage within the St. Peter Sandstone occurred at the top of the massive sections, indicating a greater degree of cementation. However, we found that geophysical log data were not sufficient to identify the Cave Unit away from outcrops.

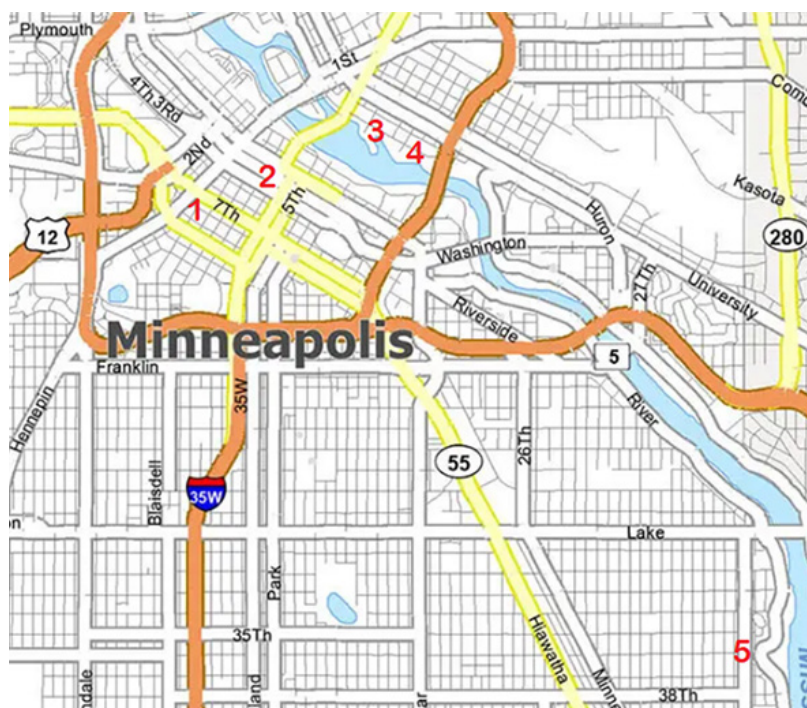
**Fig. 2. Locations of historical and natural sinkholes and voids: (1) Nicollet Mall Cave, (2) Schieks Cave, (3) Eastman Tunnel, (4) Chute's Cave, (5) 34th Street Caverns and Seven Oaks Oval Park. Base map from gisgeography.com**
