# FRESHWATER

## FINAL REPORT

### Hennepin County Bedrock Collapse Project

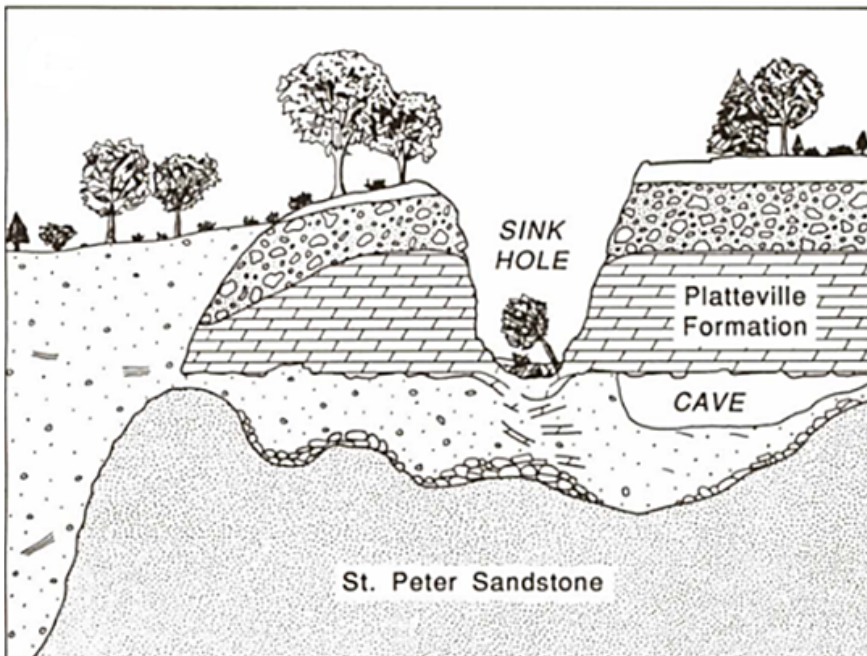
**Fig. 1. Sinkhole formation near buried bedrock valley, Twin Cities metropolitan area. Removal of supporting sand to the buried valley when it was a surface valley in pre- or interglacial times, or incomplete filling of the cave leads to collapse of the overlying limestone and soil, forming a sinkhole. Swanson, L.; Meyer, G.N. (1990).**

The term sinkhole can cover a wide range of phenomena, especially amongst laypersons, ranging from potholes in the street to meteorite craters. In this report, and geology more generally, it refers to collapse features in rock, typically limestone, usually due to undermining. In Hennepin County the cave-forming unit and therefore sinkhole unit is not limestone; it is a weakly cemented silica-sand rock layer. Silica is comparatively insoluble (unlike limestone) so the caves form as a result of the physical removal of the sand by natural or human activities with limited dissolution. Sinkholes occur when the overlying material is thin and collapses into the void, often when it becomes large enough to span joints in the overlying Platteville limestone, if present. This is different from Florida-type sinkholes, which form in the groundwater mixing zone of fresh and saline water with collapse occurring into pre-existing limestone voids that have been drained of supportive groundwater, possibly by the overdraft of nearby water wells. See Figure 1 for a generalized example.

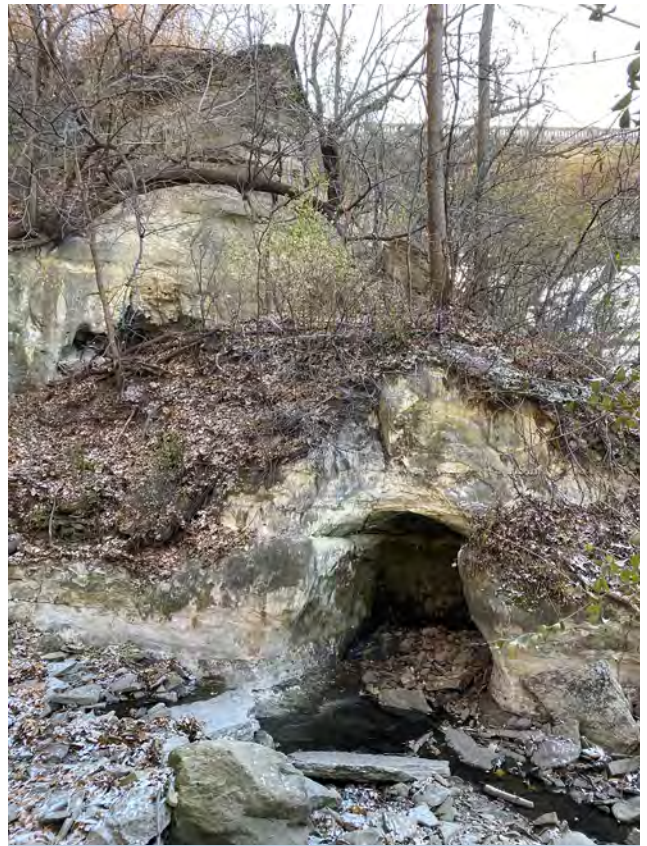
**Cave unit in the St. Peter Sandstone**

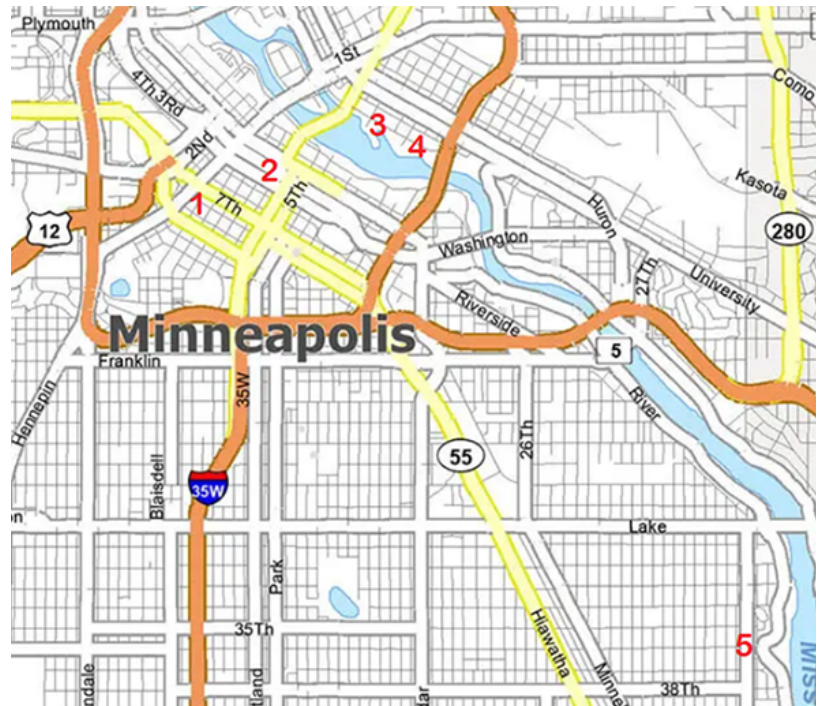
**Fig. 2. Locations of historical and natural sinkholes and voids: (1) Nicollet Mall Cave, (2) Schieks Cave, (3) Eastman Tunnel, (4) Chute’s Cave, (5) 34th Street Caverns and Seven Oaks Oval Park. Base map from gisgeography.com**

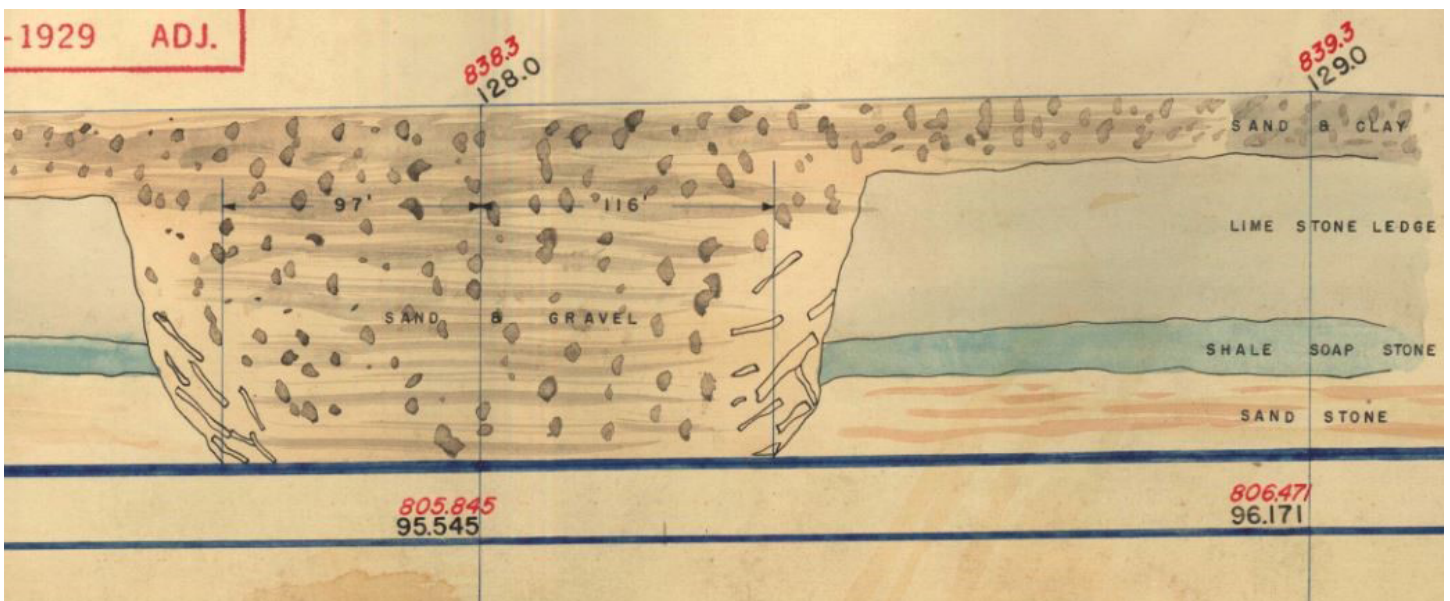
Fig 3. A “classic” sinkhole as depicted on sewer lines, 2nd Street NE and 5th Avenue NE.

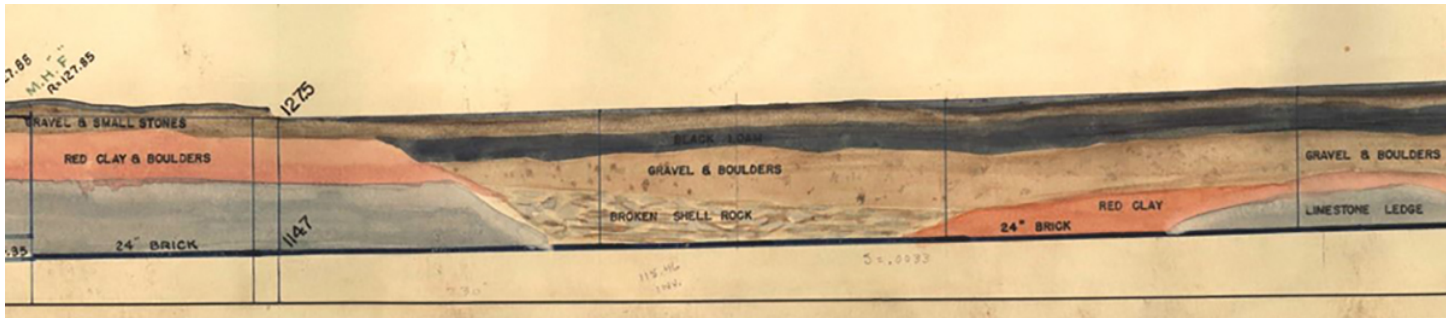
**Fig 4. The giant “broken shell rock” sinkhole at Adams Street NE north of Spring Street NE.**

At Adams Street NE north of Spring Street NE, there is a 150-foot gap in the shallow limestone filled with “broken shell rock,” with the depiction of thinned sediments along the edges of the gap. This appears to be an old sinkhole (Fig. 4). More recent sediments overlie the gap and appear to be horizontally layered.

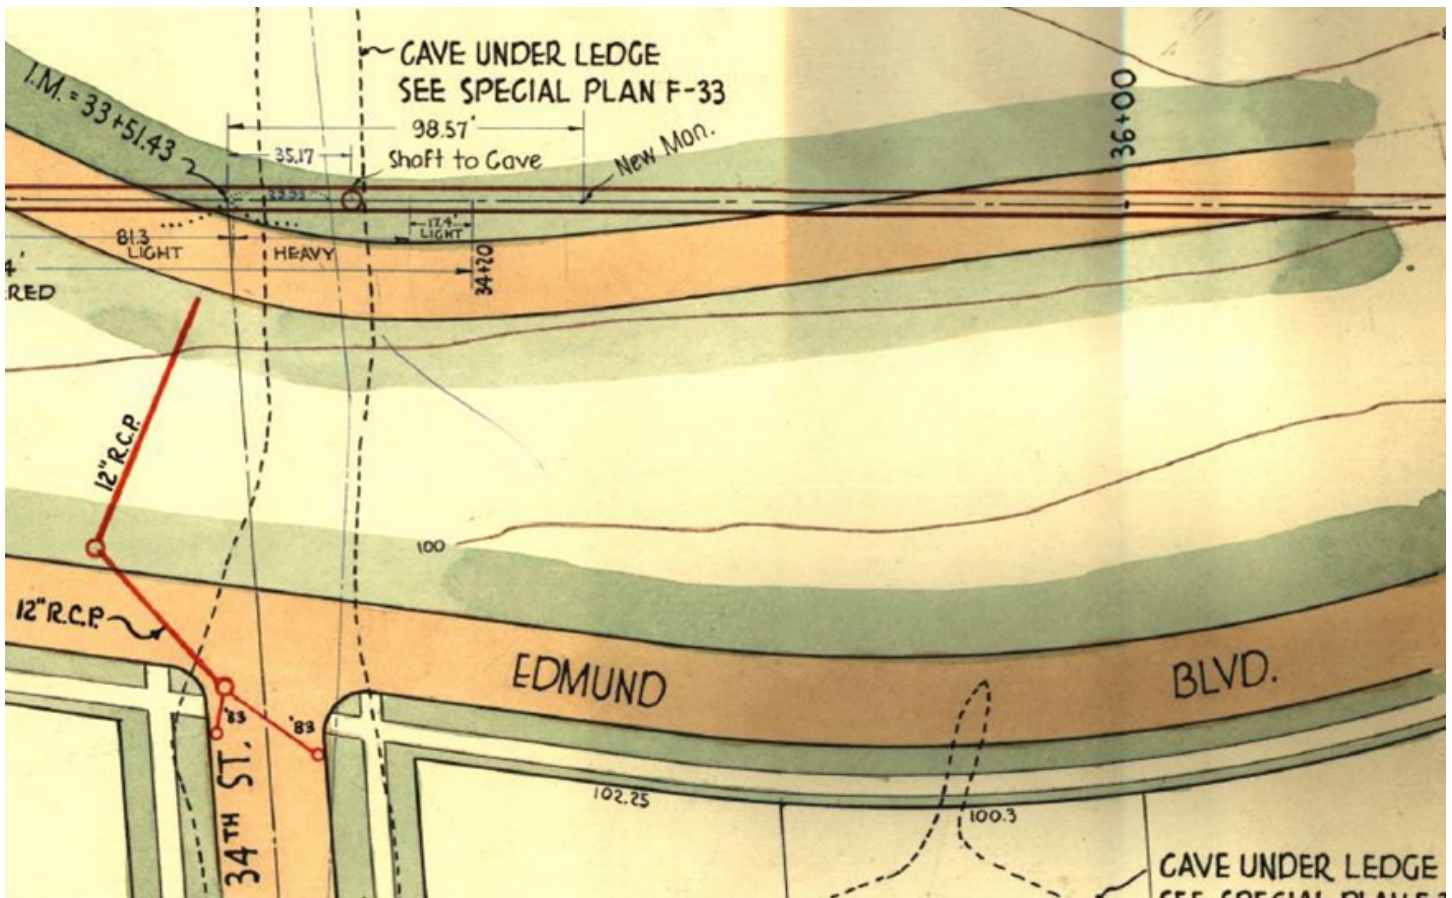
**Fig 5. Storm drain rerouted to avoid 34th Street Cavern (dashed lines).**

On Park Terrace and 34th Street South on the north side of the Seven Oaks Oval Park, the storm and sanitary sewers are routed around the sinkhole. The storm drain on 34th Street and Edmund Blvd. in particular is routed diagonally through the intersection to avoid the cavern northeast of the sinkhole (Fig. 5). This shows how sewers are routed around caverns where they are known to exist before being constructed.

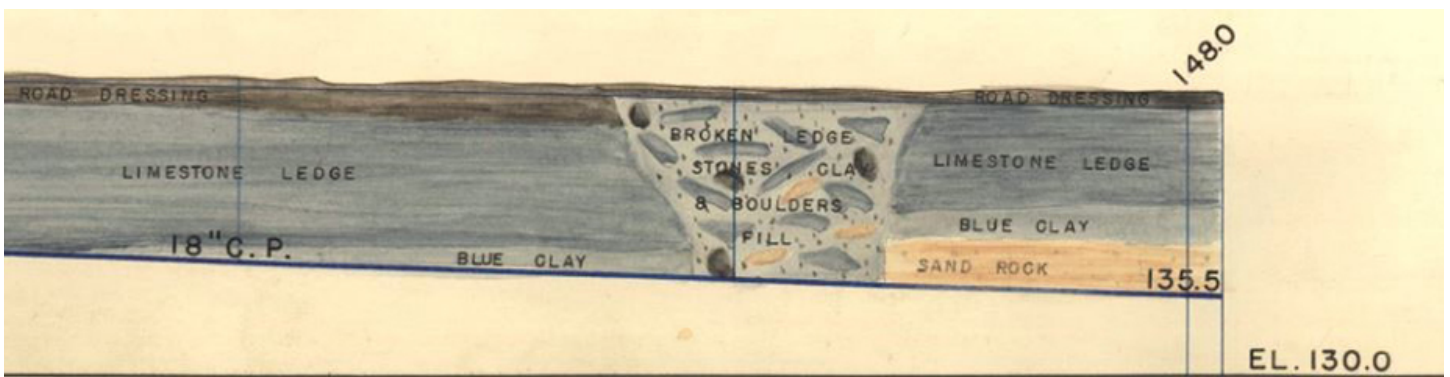
**Fig. 6. The Lyndale Sinkhole likely formed along the offset between rock layers.**

At Lyndale Avenue North, the sewer crosses a 120-foot wide gap in the shallow limestone bedrock south of 40th Street North that is filled with “broken ledge, stones, clay, and boulders fill,” with the profile depicting a dramatic

sketch of a pipe-shape filled with randomly oriented blocks (Fig. 6). The top of the Glenwood Shale is measured (the drawings being to scale in three dimensions, as the sewers were surveyed in three dimensions to the nearest one-tenth of a foot) as being three feet higher on the north side of the hole compared to the south side. Sandstone is shown on the north side of the hole and not on the south side. This appears to be an old sinkhole caused by drainage through a small fault or offset joint between the limestone and the sandstone.

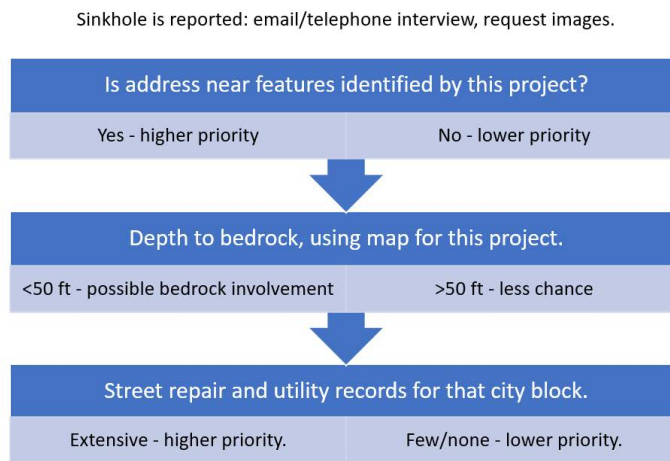
Site investigation by geologist if sinkhole is reported to be growing deeper than the deepest pipe at the site, or lost material can't be accounted for.

**Fig. 7. Detailed construction records can be of immeasurable value to identifying historical collapses of bedrock in urban areas.**

A general order of investigation to rule out less hazardous instances can be conducted by a lay person up to a point. The steps involved are listed here (Fig. 7). Protocol for a professional geologist is provided in the appendix.

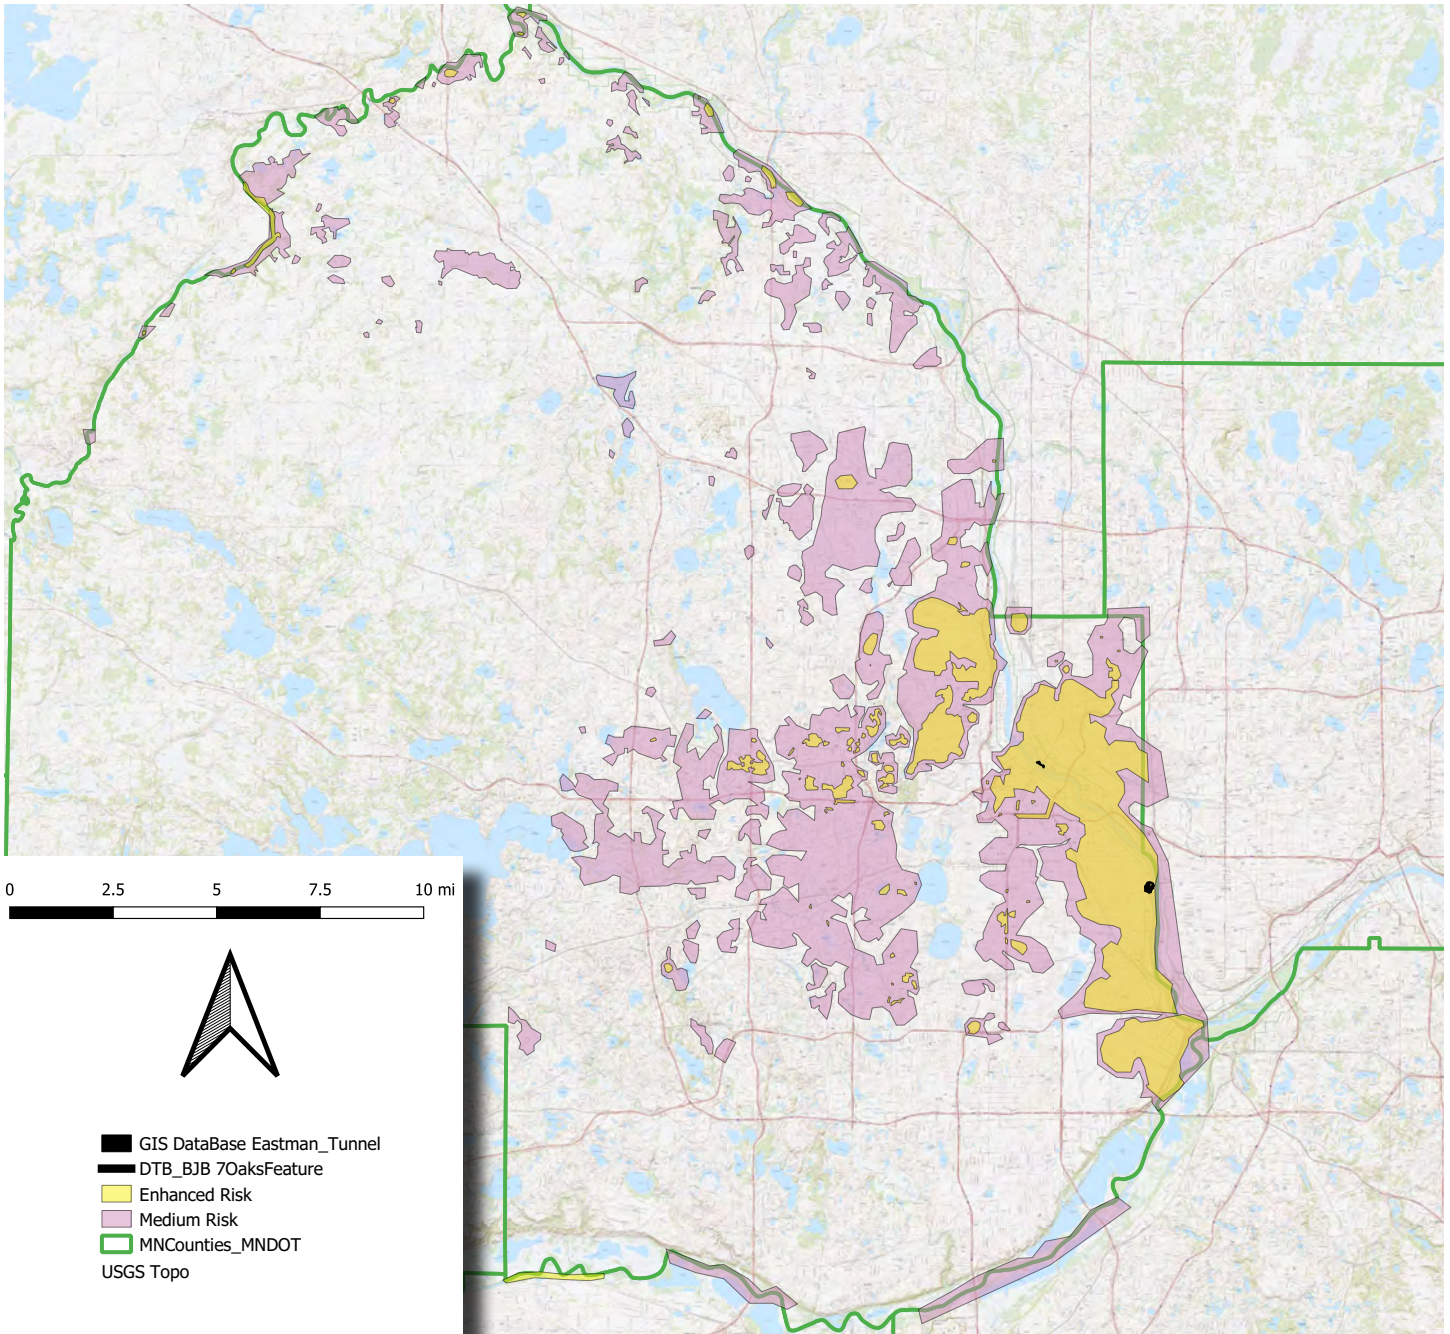
## HENNEPIN COUNTY BEDROCK COLLAPSE RISK

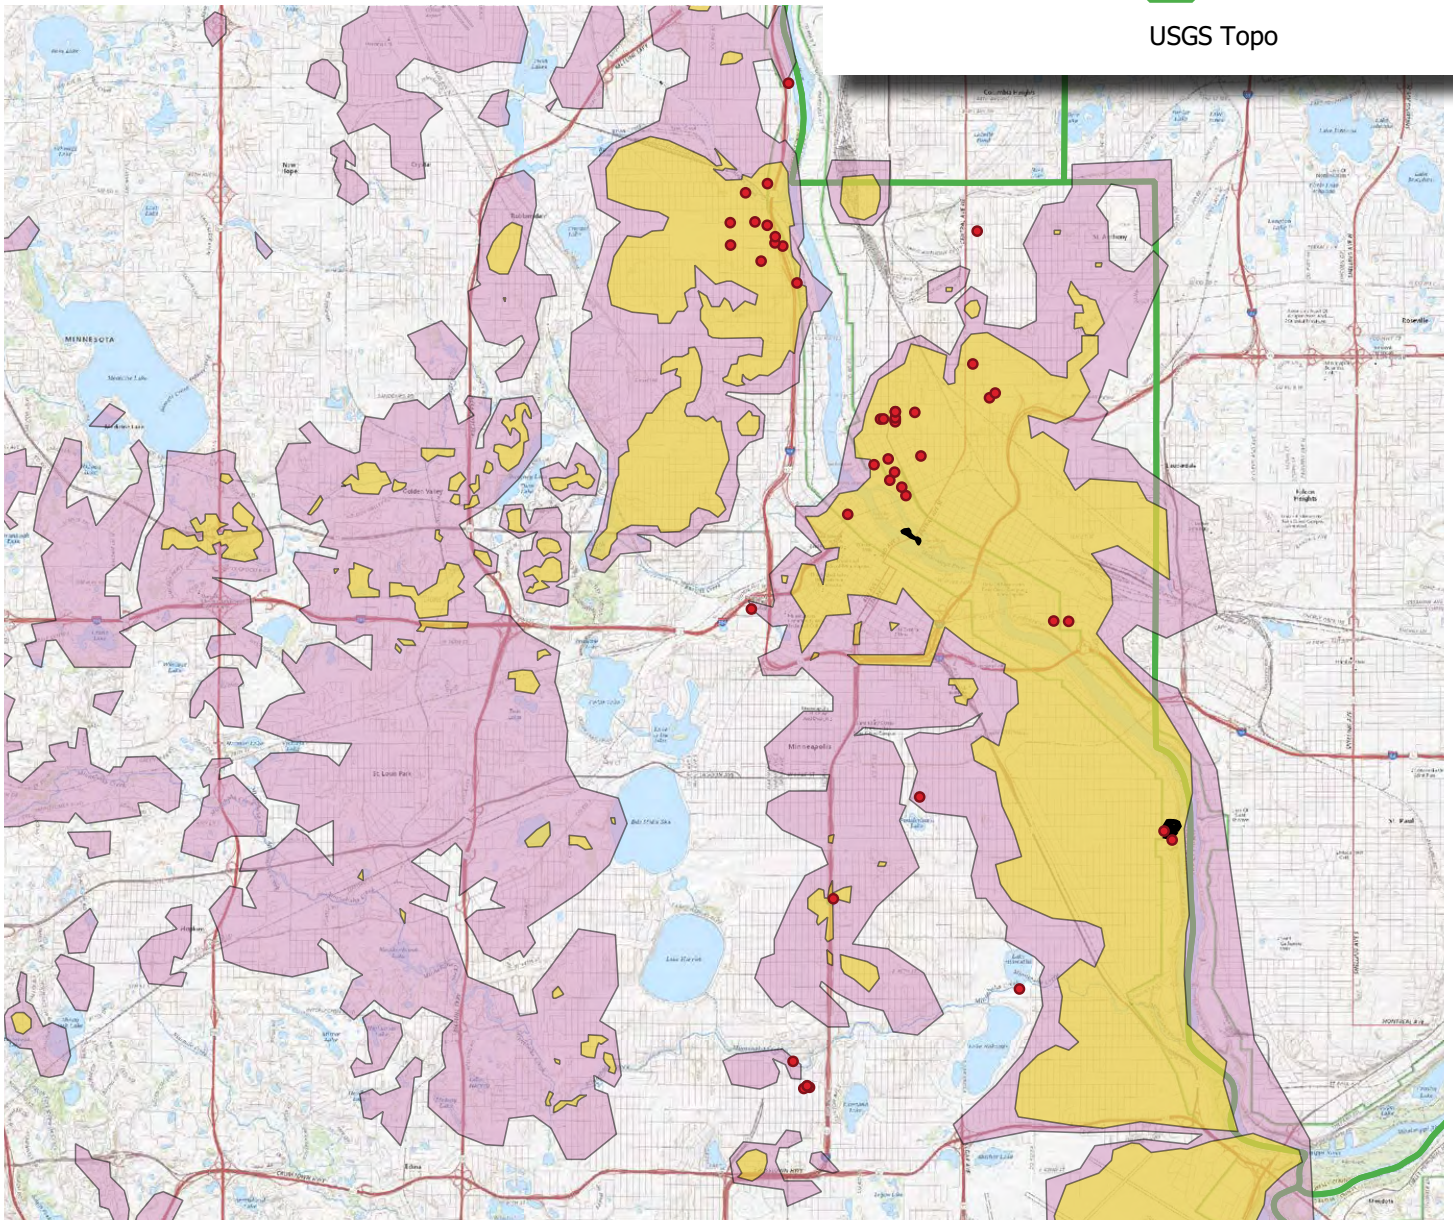
# POSSIBLE BEDROCK COLLAPSE FEATURES FROM MINNEAPOLIS SEWER RECORDS
